**Flood Control Project Maintenance
Levee Inspections**

Maintenance Issue Types Only, Levee Inspection Report By Mile - Fall 2018

Reclamation District No. 0001 Union Island

Waterway	Bank	Unit Miles	Inspection Start/End	Inspector
Unit No. 01 Old River	Right	1.14	10/09/2018 10/09/2018	Richard Willoughby

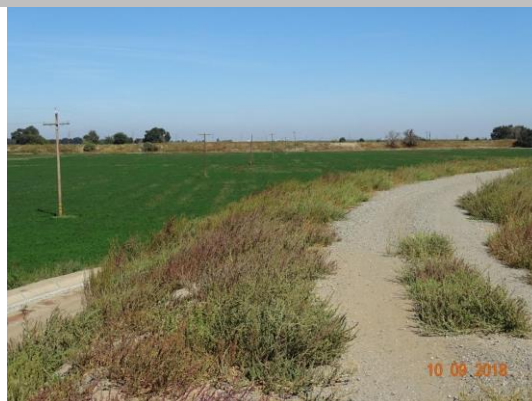
Photo 1 of 1 : FA_2018_RD0001_23_13_20181011_00023.jpg

LM Start	0.00	Rating **	U	Issue No.	13
LM End	1.14	Issue Type +	Ma	Location *	LS
Category	Earthen Levee			GPS Latitude/Longitude	
				Start	End
Item	Vegetation			37.822580°	37.811714°
				-121.375545°	-121.384876°
DWR ID	DWR_RD0001_01_f_2018_13				
Comment Code					
V2 : Remove the wild growth other than native grasses from the levee slopes.					
Inspector Comment

Looking southwest at typical view of landward slope.

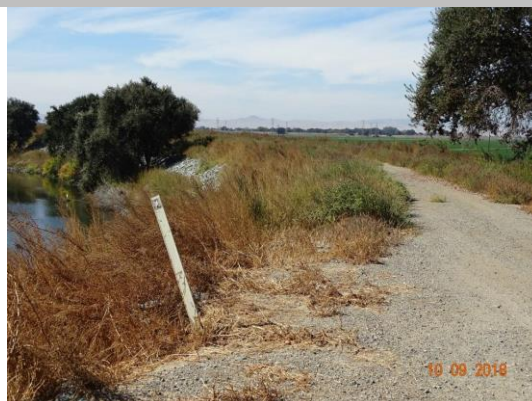
Photo 1 of 1 : FA_2018_RD0001_23_20_20181011_00024.jpg

LM Start	0.00	Rating **	U	Issue No.	20
LM End	1.14	Issue Type +	Ma	Location *	WS
Category	Earthen Levee			GPS Latitude/Longitude	
				Start	End
Item	Vegetation			37.822585°	37.811714°
				-121.375532°	-121.384876°
DWR ID	DWR_RD0001_01_f_2018_20				
Comment Code					
V2 : Remove the wild growth other than native grasses from the levee slopes.					
Inspector Comment

Looking east at typical view of waterward slope.

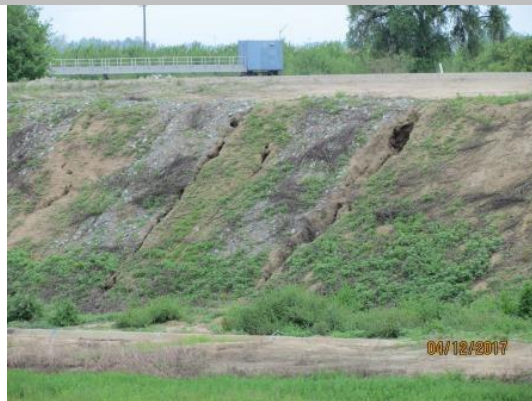
Photo 1 of 1 : FA_2018_RD0001_23_18_20180906_00015.jpg

LM Start	0.21	Rating **	M	Issue No.	18
LM End	0.21	Issue Type +	Ma	Location *	LS
Category	Earthen Levee			GPS Latitude/Longitude	
				Start	End
Item	Erosion / Bank Caving			37.820806°	37.820806°
				-121.378260°	-121.378260°
DWR ID	DWR_RD0001_01_s_2017_18				
Comment Code					
E2 : Schedule repair of erosion site prior to the next inspection.					
Inspector Comment

View of the erosion on the levee slope.

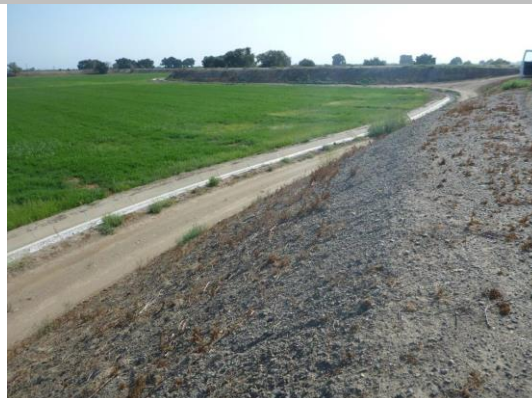
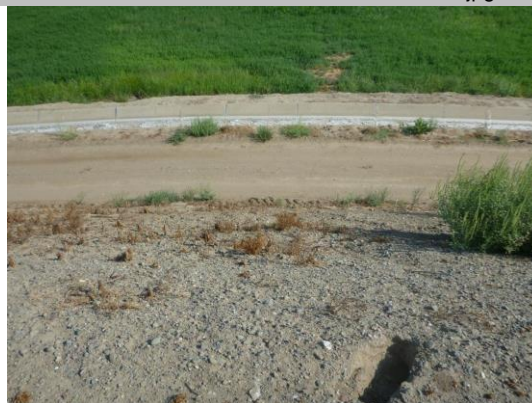
LM Start	0.31	Rating **	M	Issue No.	11	
LM End	0.33	Issue Type +	Ma	Location *		
Category	Supplemental			GPS Latitude/Longitude		
				Start	End	
Item	2017 Storm Damage			37.820300 °	37.820200 °	
				-121.379500 °	-121.379800 °	
DWR ID	DWR_RD0001_01_f_2017_11

Comment Code						
Inspector Comment						
Levee Evaluation Comments						
Description:Slope protection repairs are needed along the waterside slope due to erosion and riprap displacement from high water. Based upon levee inspections, it was determined the waterside levee slope is eroding, deteriorating, and degrading. The eroded levee sections need to be restored back to design standards to prevent further deterioration and damage.						
Site ID No:496						
Site Designation:LMA-402						
Repair Type: Erosion						
Rating:Area of Concern						
Field Date:8/18/2017						
Notes: Start of outside bend. Minor toe erosion has displaced riprap.

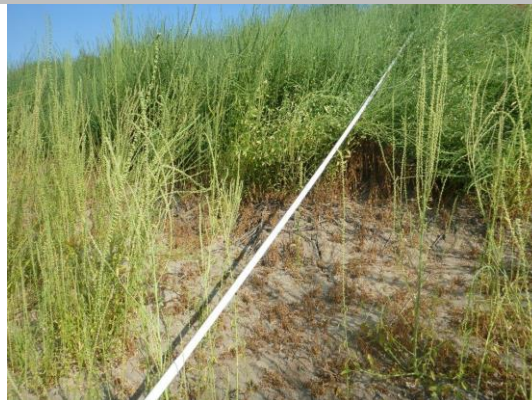
Photo 3 of 3 : LEVAL_FA_2018_496_4374.jpg

LM Start	0.31	Rating **	M	Issue No.	11 (cont)	
LM End	0.33	Issue Type +	Ma	Location *		
Category	Supplemental			GPS Latitude/Longitude		
				Start	End	
Item	2017 Storm Damage			37.820300 °	37.820200 °	
				-121.379500 °	-121.379800 °	
DWR ID	DWR_RD0001_01_f _ 2017_11

Comment Code						
Inspector Comment						
Levee Evaluation Comments						
Description:Slope protection repairs are needed along the waterside slope due to erosion and riprap displacement from high water. Based upon levee inspections, it was determined the waterside levee slope is eroding, deteriorating, and degrading. The eroded levee sections need to be restored back to design standards to prevent further deterioration and damage.						
Site ID No:496						
Site Designation:LMA-402						
Repair Type: Erosion						
Rating:Area of Concern						
Field Date:8/18/2017						
Notes: Start of outside bend. Minor toe erosion has displaced riprap.

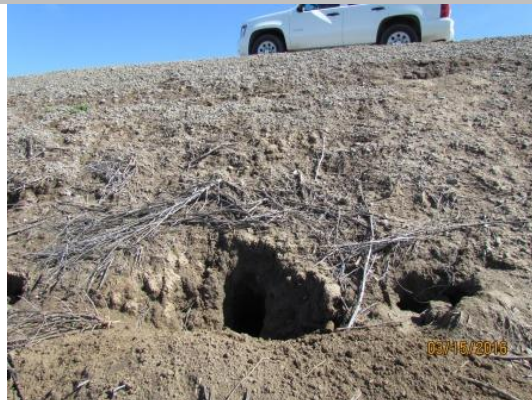
Photo 1 of 1 : FA_2018_RD0001_23_14_20180906_00011.jpg

LM Start	0.44	Rating **	U	Issue No.	14
LM End	0.44	Issue Type +	Ma	Location *	LS
Category	Earthen Levee			GPS Latitude/Longitude	
				Start	End
Item	Animal Control			37.818898 °	37.818898 °
				-121.380332 °	-121.380332 °
DWR ID	DWR_RD0001_01_s_2016_14				
Comment Code					
A1 : Exterminate rodents and backfill and compact or grout burrows.					
Inspector Comment					
Active rodent den a size of a coyote or fox.

View of the large rodent hole on the landside levee slope.

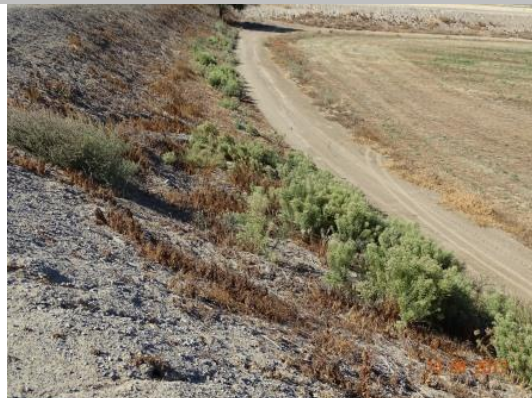
Photo 2 of 2 : FA_2018_RD0001_23_3_20180906_00002.jpg

LM Start	1.08	Rating **	M	Issue No.	3 (cont)	
LM End	1.08	Issue Type +	Ma	Location *	LS	
Category	Earthen Levee			GPS Latitude/Longitude		
				Start		End
Item	Slope Stability			37.812023 °		37.812023 °
				-121.383961 °		-121.383961 °
DWR ID	DWR_RD0001_01_s_2016_3					
Comment Code						
S3 : Repair the levee slope damaged by vehicle traffic and prevent access where possible.						
Inspector Comment						
Repair slope damaged by vehicle by placing and compacting acceptable levee material.

View of the ruts on the levee slope overgrown with vegetation.

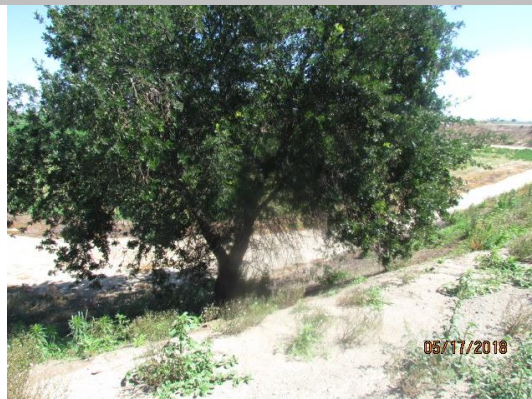
Photo 1 of 1 : FA_2018_RD0001_23_19_20180906_00016.jpg

LM Start	1.13	Rating **	M	Issue No.	19
LM End	1.13	Issue Type +	Ma	Location *	LS
Category	Earthen Levee			GPS Latitude/Longitude	
				Start	End
Item	Trim / Thin Trees			37.811714 °	37.811714 °
				-121.384876 °	-121.384876 °
DWR ID	DWR_RD0001_01_s_2018_19				
Comment Code					
T1 : Trim trees to at least five feet above ground level.					
Inspector Comment

Looking west at untrimmed tree at landward toe. (Spring 2018)
